DOT HS-801-969

# CRASHWORTHINESS OF THE SUBCOMPACT VEHICLE

August 1976

Final Report

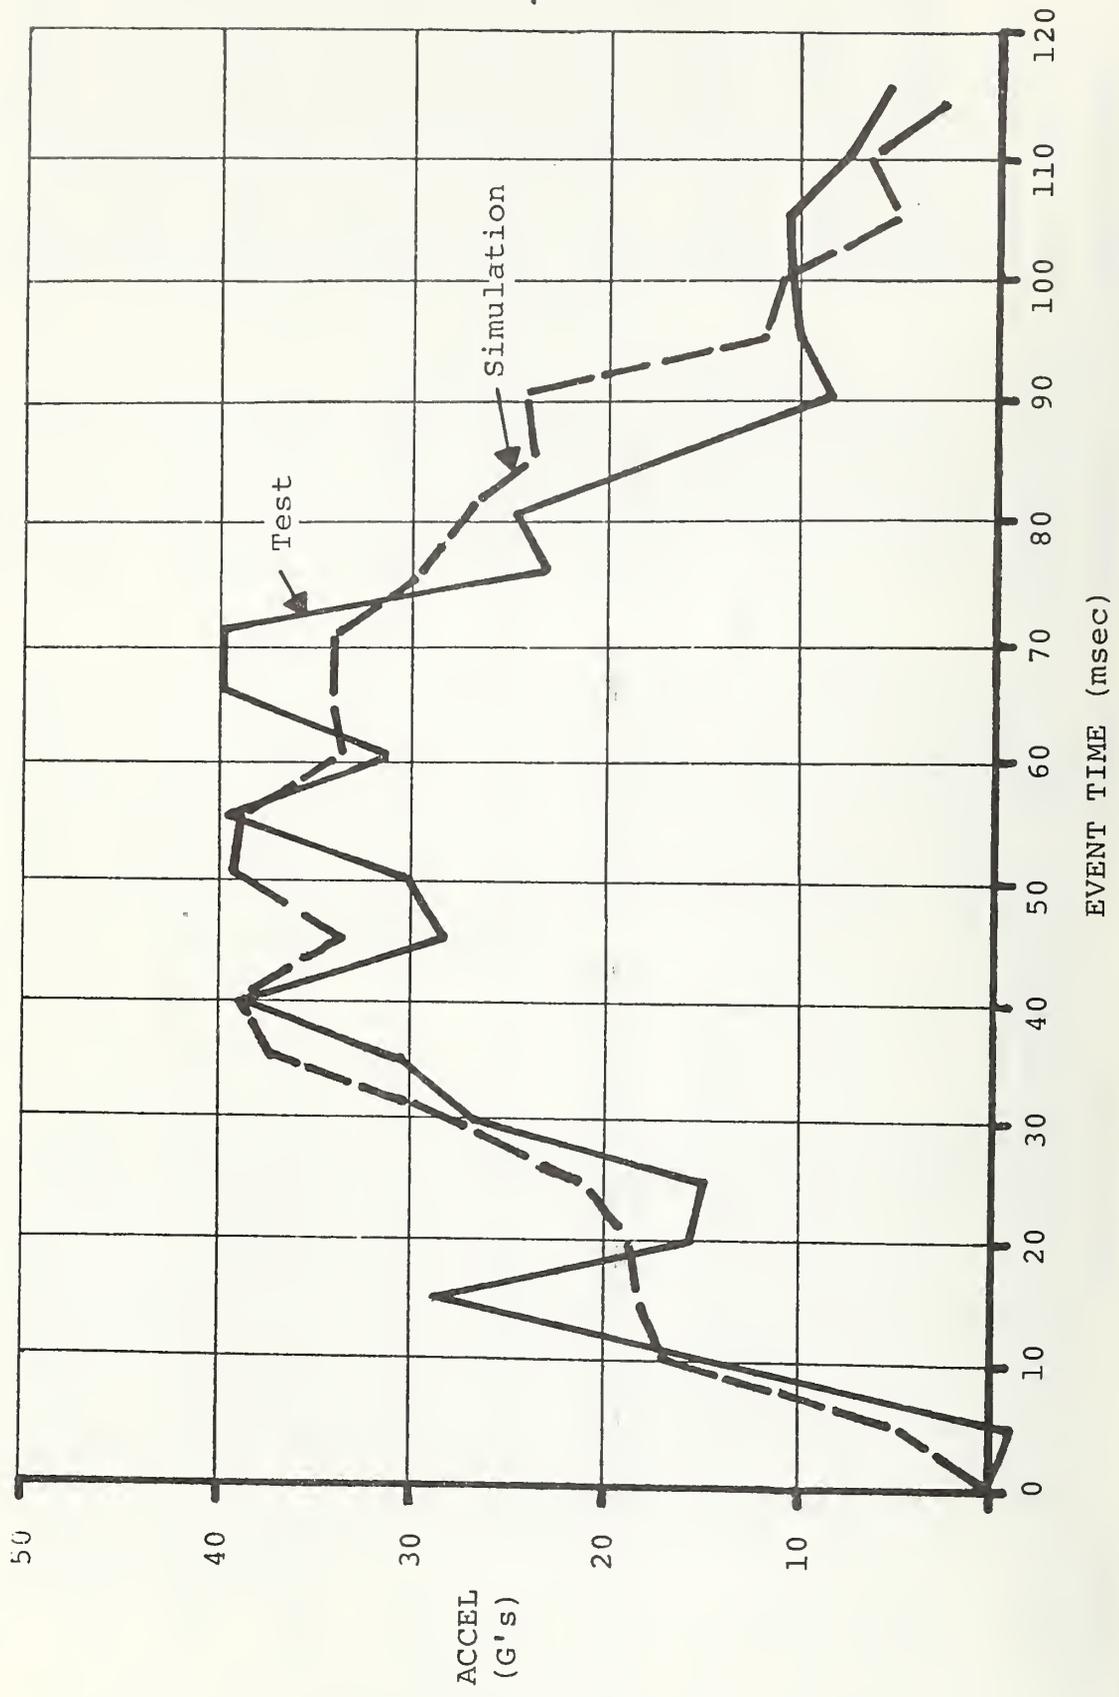
FIGURE 1.4 TENMASS MODEL CORRELATION SUBCOMPACT VEHICLE  
 1974 Pinto and 1968 Plymouth

paths through the vehicle front structure. Initial velocity conditions were applied to the masses and a time step integration was used to calculate the dynamic response. The results of the modeling were correlated with baseline test data as shown in Figure 1.4.

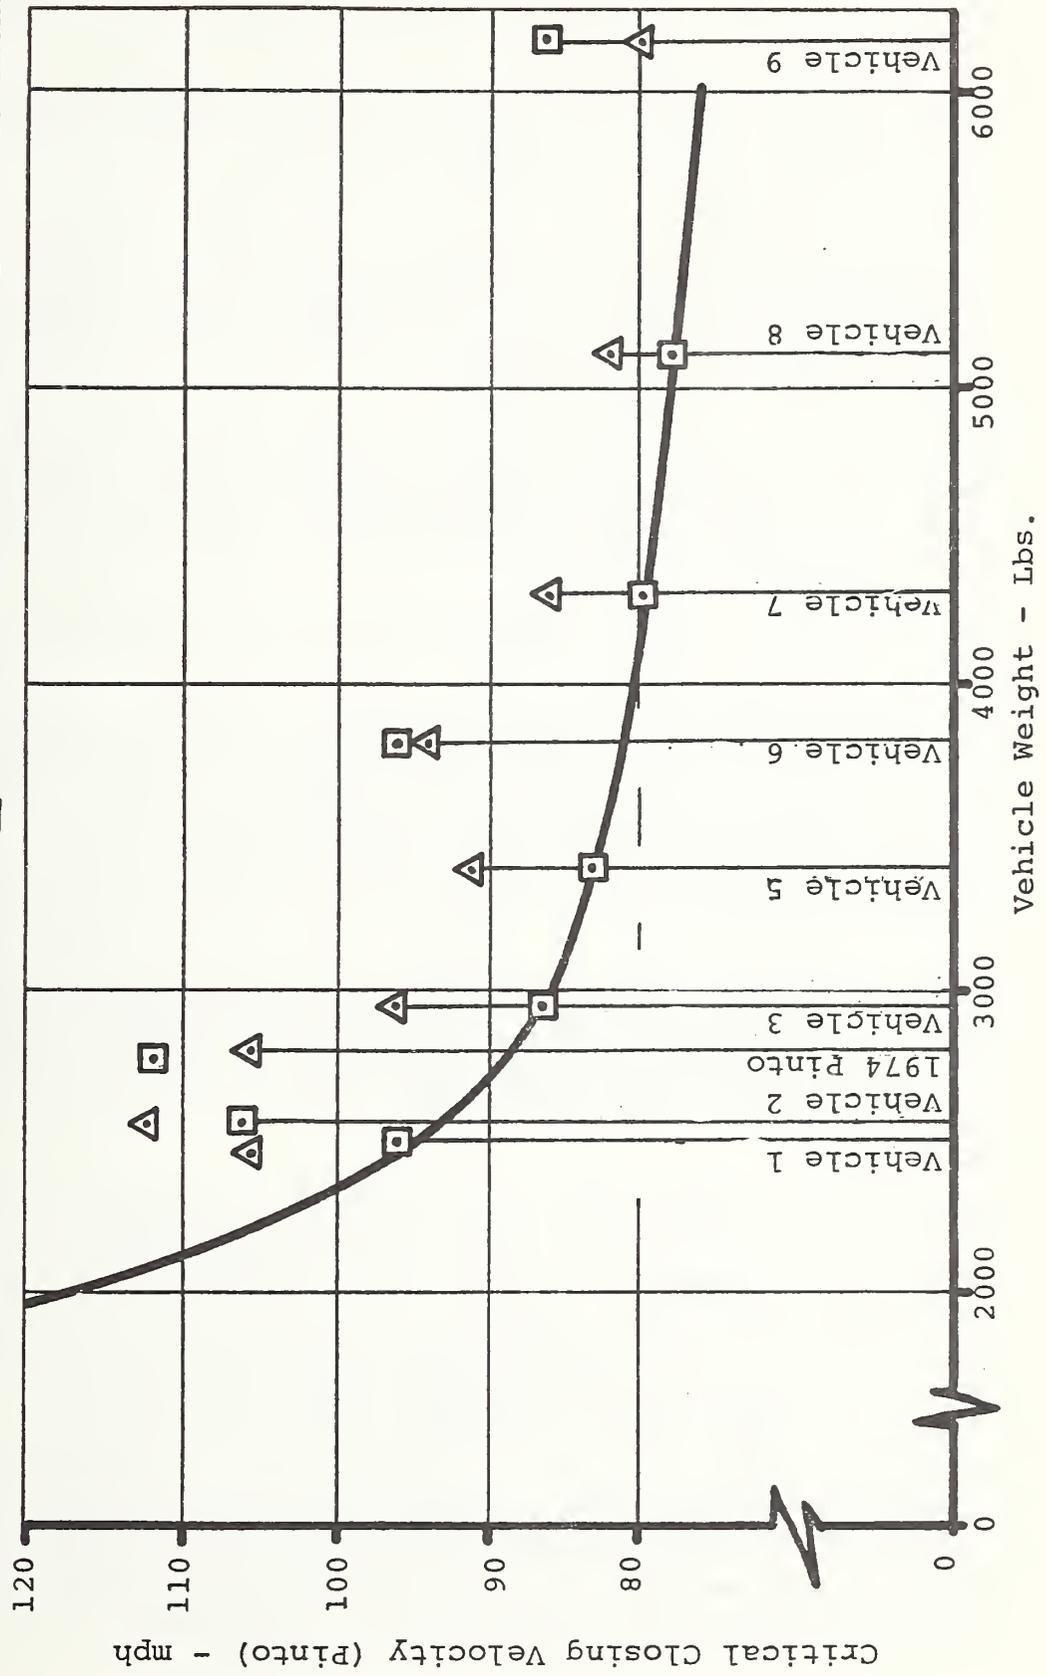
FIGURE 2.22 CRITICAL VELOCITY CURVE FOR 1974 PINTO SEDAN

- Critical Occupant Stroke Limit = 20 inches
- △ Critical Vehicle Crush Limit = 45 Inches

and crush critical velocity are plotted for each impact. Three important results can be observed from the curve.

The 45 inches of crush represents 75 percent of the total distance from the bumper face to the A post. The 75 percent structural efficiency is typical of values found in automobile crash studies. The 20-inch occupant stroke represents the head to windshield distance for a 50th percentile occupant for the conditions listed above. The critical closing velocity is defined as the maximum velocity attainable prior to exceeding either of these parameters for the Pinto or Pinto occupant.

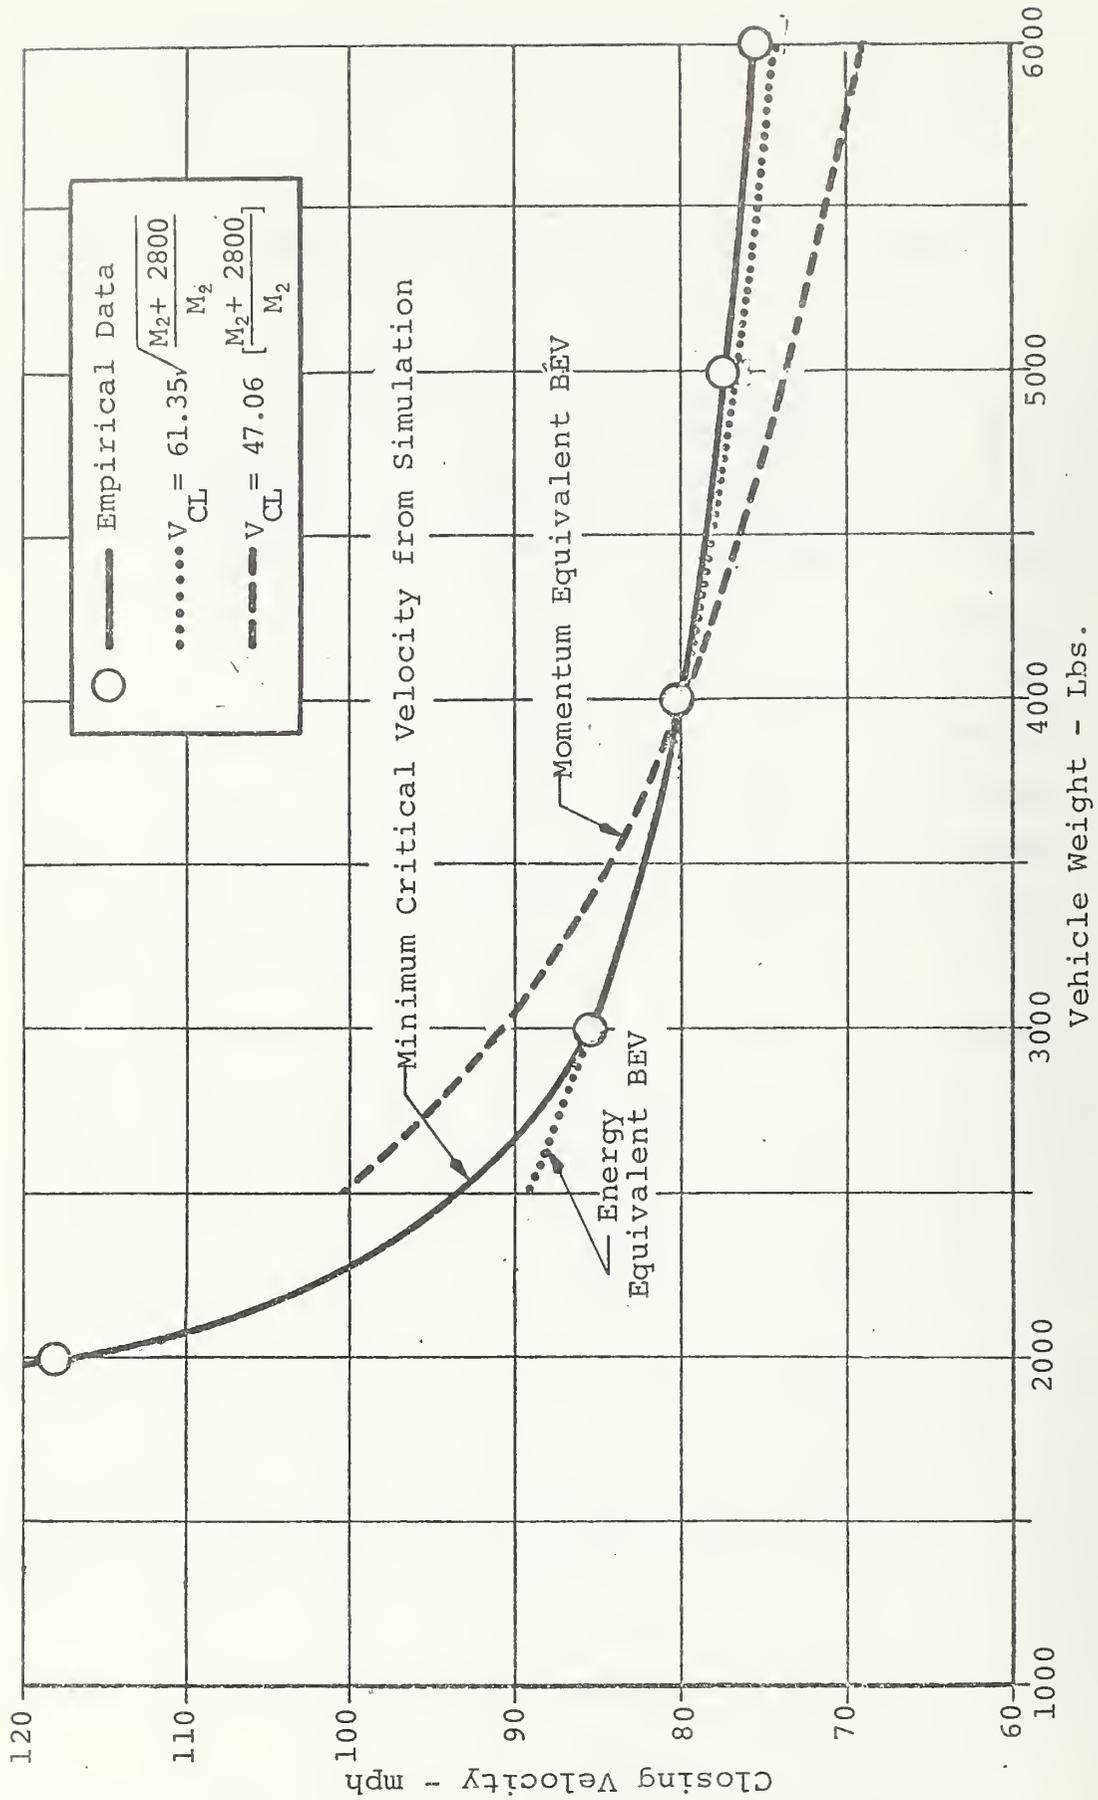
FIGURE 2.23 COMPARISON OF BEV DEFINITIONS VS. MINIMUM CRITICAL SPEED FOR 1974 PINTO

<u>Weight</u>	<u>Minimum Critical Curve (Fig. 8) (mph)</u>	<u>Energy BEV (mph)</u>	<u>Momentum BEV (mph)</u>
2500	95	89.3	99.8
3000	86	85.3	91.0
3500	82	82.3	84.7
4000	80	80.0	80.0
4500	79	78.1	76.3
5000	78	76.6	73.4
5500	77	75.4	71.0
6000	76	74.3	69.0

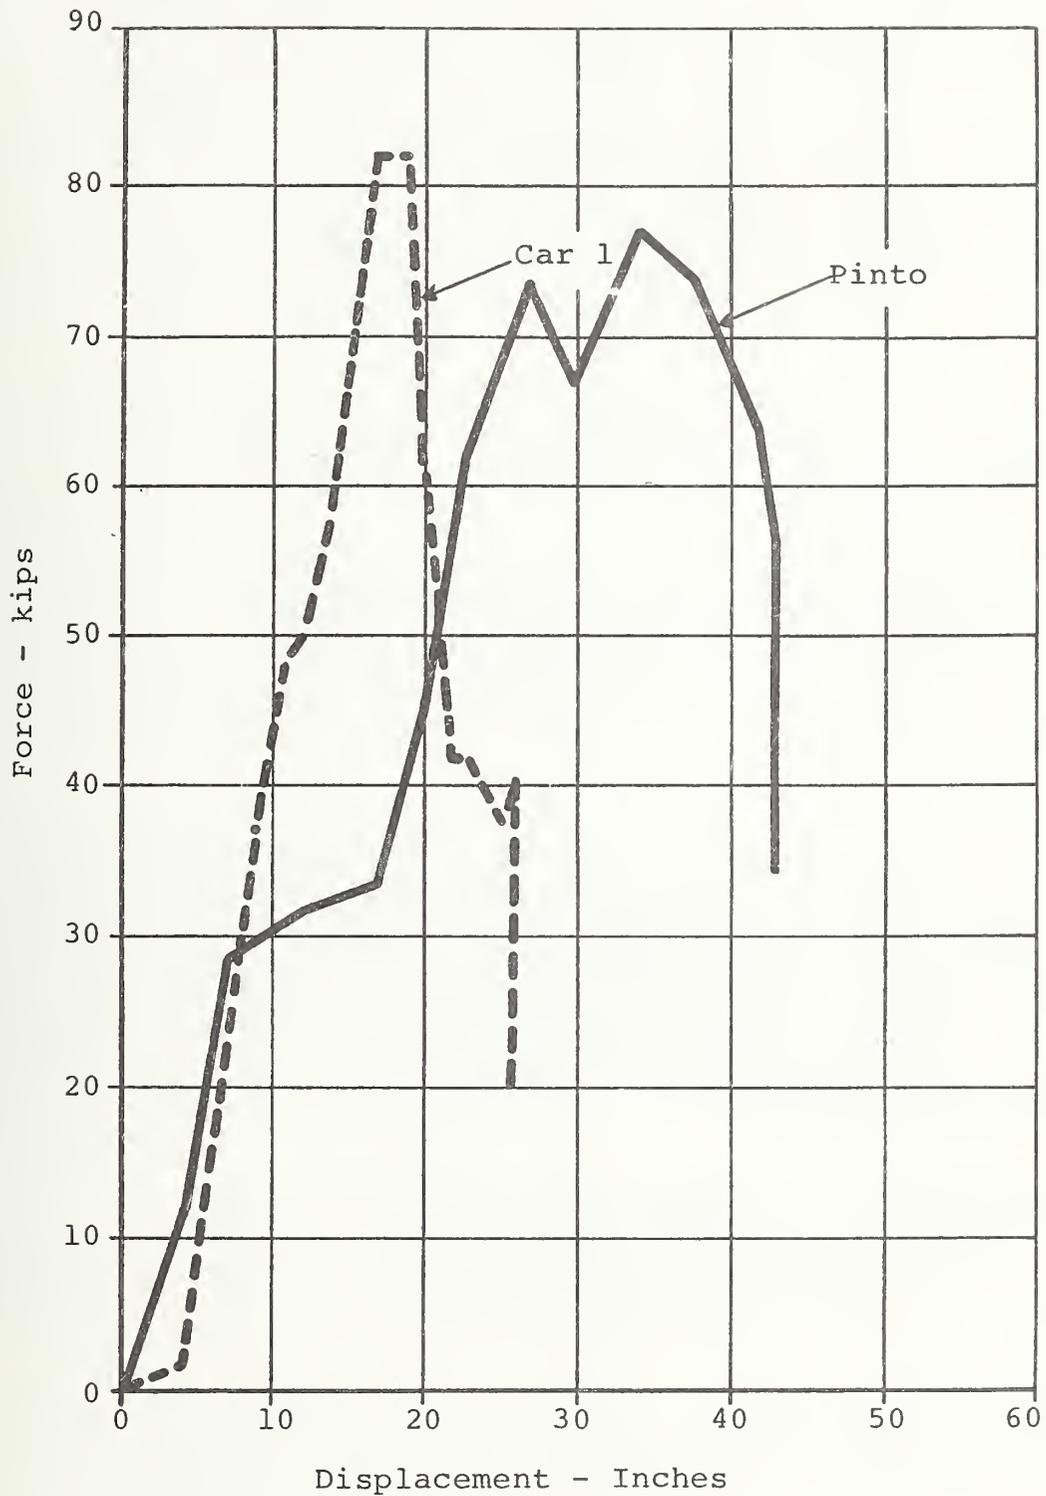
FIGURE 2.24 OVERALL FORCE-DISPLACEMENT CHARACTERISTICS FOR UNMODIFIED 1974 PINTO IMPACTING CAR 1 AT 100 MPH CLOSING VELOCITY

Even here, one has to be careful, for the relative amount of crush between the two cars for this closing velocity may change or even reverse at higher closing velocities. This can happen, for example, if the structural components of Car 1 (which are stronger than those of the Pinto up to some point in the crush of Car 1) would buckle catastrophically at further increase in load, while the Pinto becomes increasingly stiff. From this point on, further increases in the closing velocities between the two vehicles would cause Car 1 to crush more and more, absorbing an increasingly greater percentage of the total crash energy. This trend could continue to the point that at some high closing velocity the crush of Car 1 could actually exceed that of the Pinto, so that the trend noted for the original closing velocity of 100 mph is now reversed.

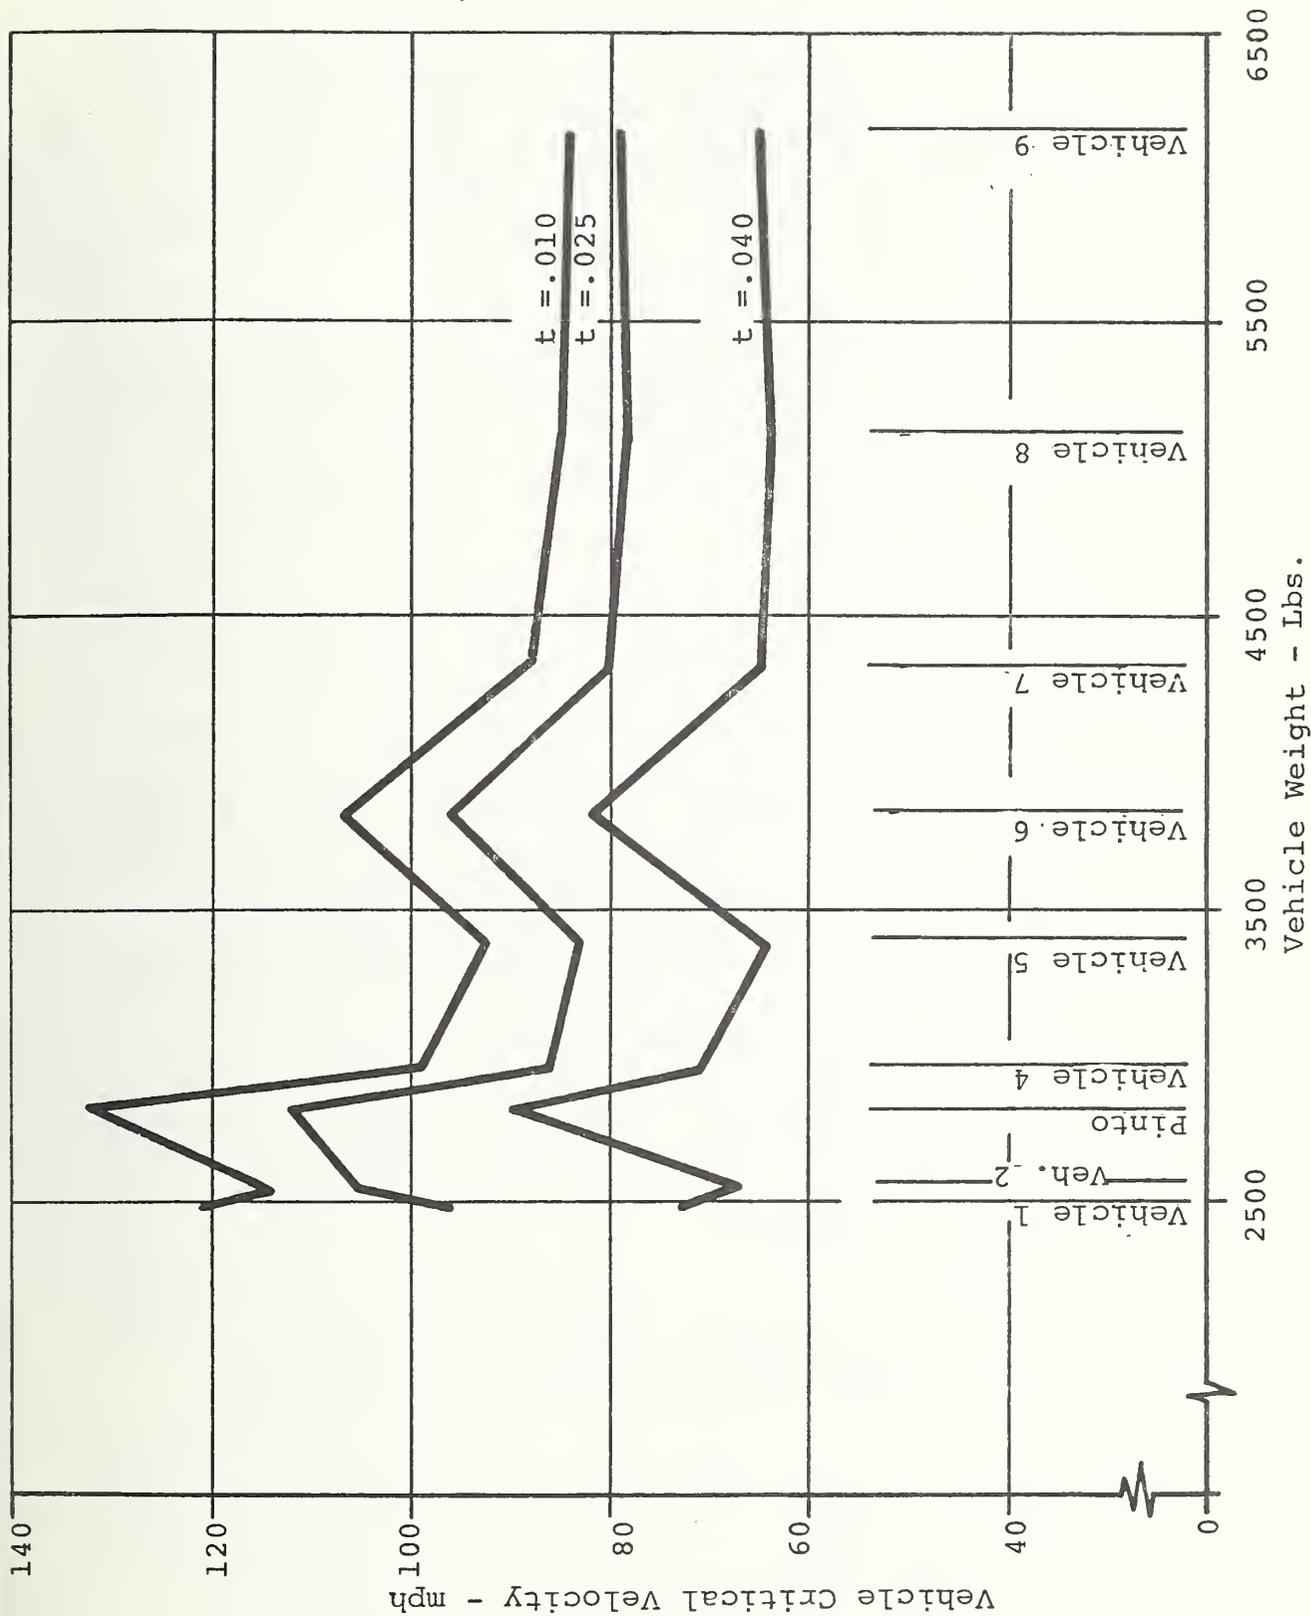
FIGURE 2.25 CRITICAL CLOSING VELOCITIES FOR RESTRAINT DEPLOYMENT TIMES OF .010, .025, AND .040 SECONDS

There are many other parameters of the restraint system which could be studied to determine their effect on the critical closing velocity. The deployment time was selected as being the most appropriate to a structural crashworthiness contract. Such items as airbag size, knee restraint angle, etc. are better studied as part of a restraint contract. This study does illustrate that improvement in restraint systems will increase the critical closing velocity.

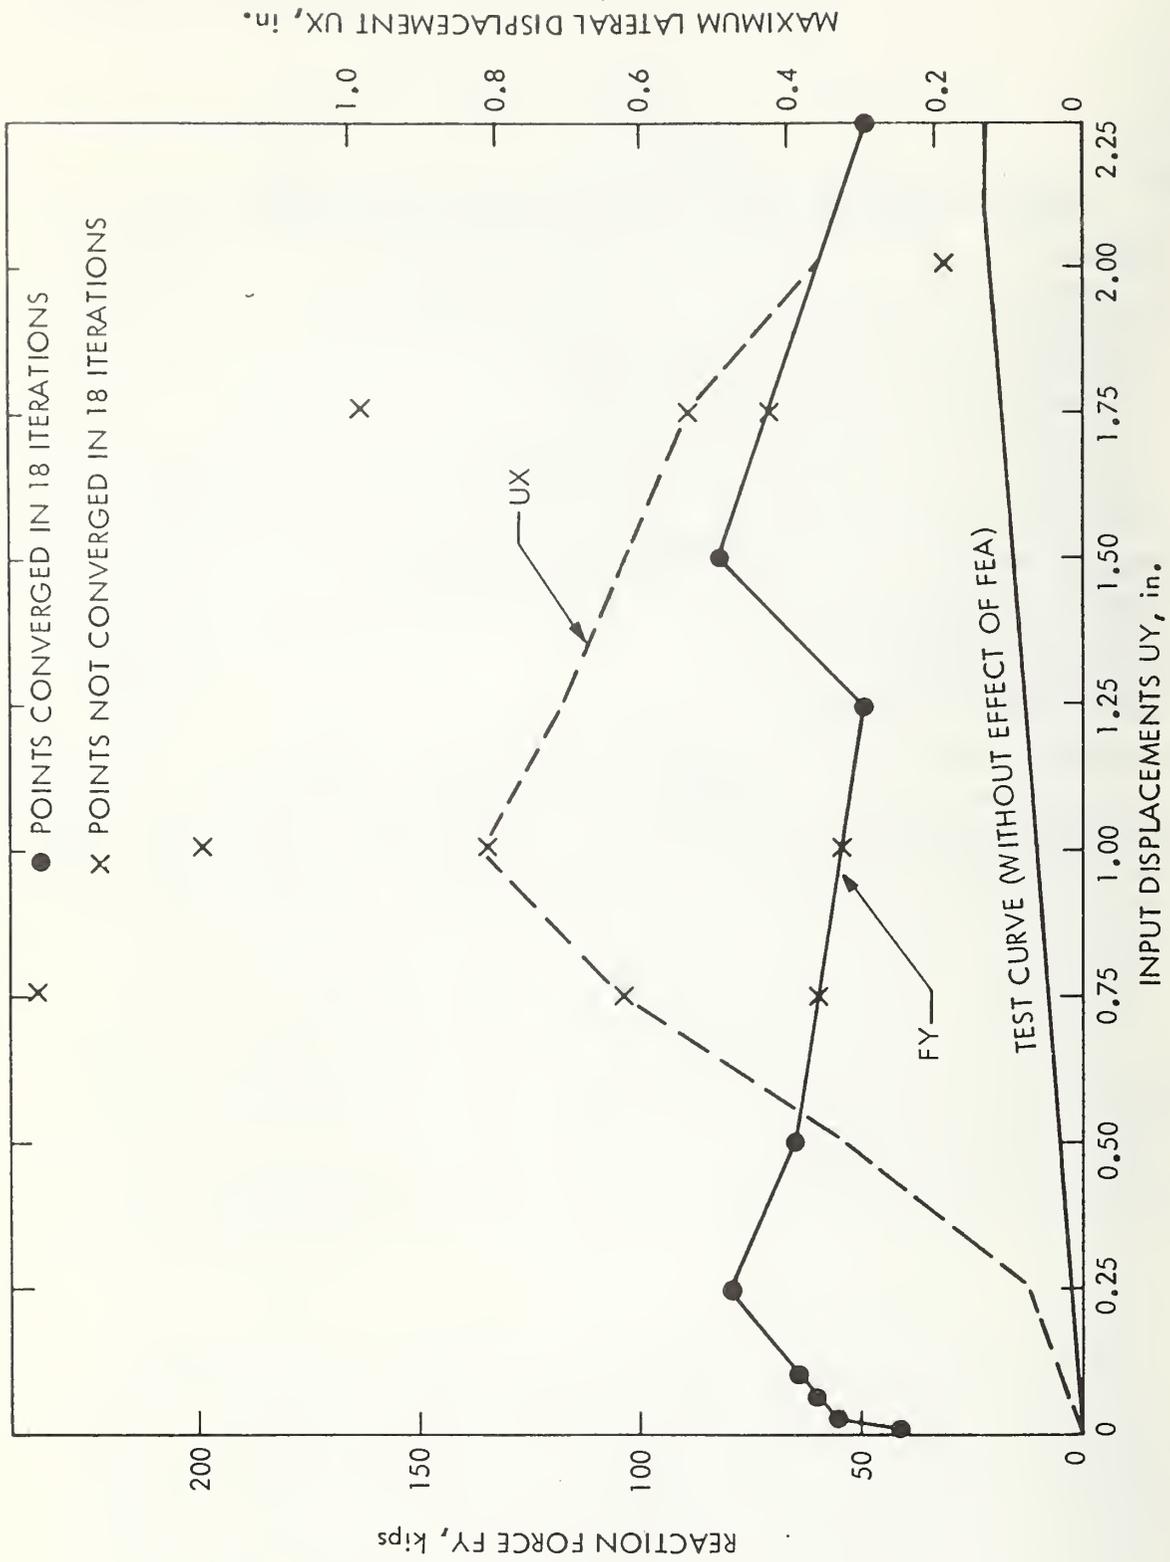
FIGURE 2.34 ANSYS MODEL II

Model I	Model II
Element Type	3D elasto-plastic flat triangular shell	2D elasto-plastic beam
Number of Elements	137	9
Number of Nodes	76	10
Convergence Criteria	0.05	0.05
Boundary Condition	UX=UY=UZ=0 at engine mount points	Refer to Fig. 2.33
Material Property	Modulus = $30 \times 10^6$ psi for $0 \leq \epsilon < 0.001$ = $0.1 \times 10^6$ psi for $0.001 < \epsilon < 1.0$

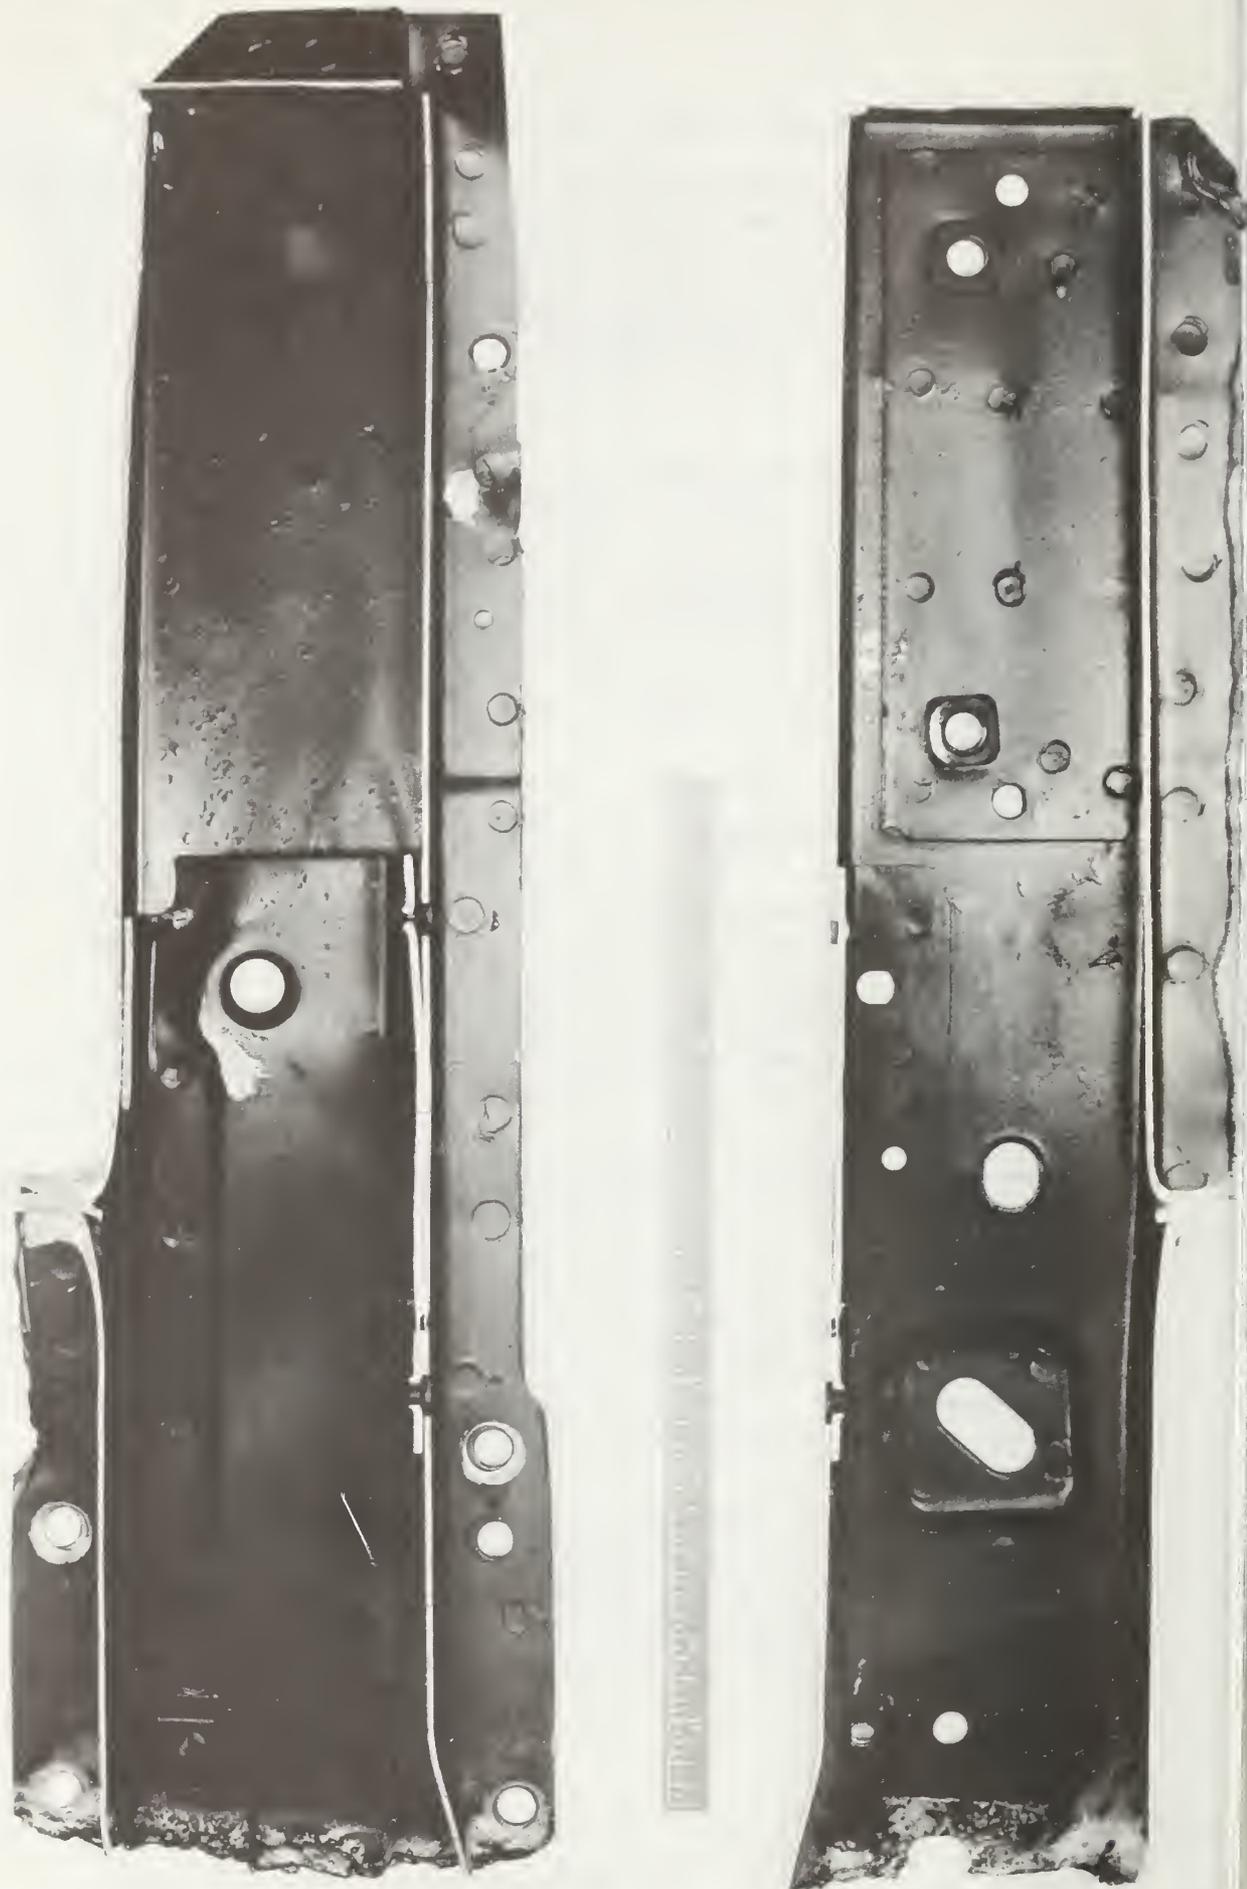
FIGURE 3.11 PRODUCTION SUBFRAME  
3.26

Since Minicars had added the oblique and offset impact as design goals, it was necessary to deal with the uni-directional nature of the crush tubes. To provide lateral support, two diagonal crush tubes were added, running from the upper fenders to the center of the firewall. The

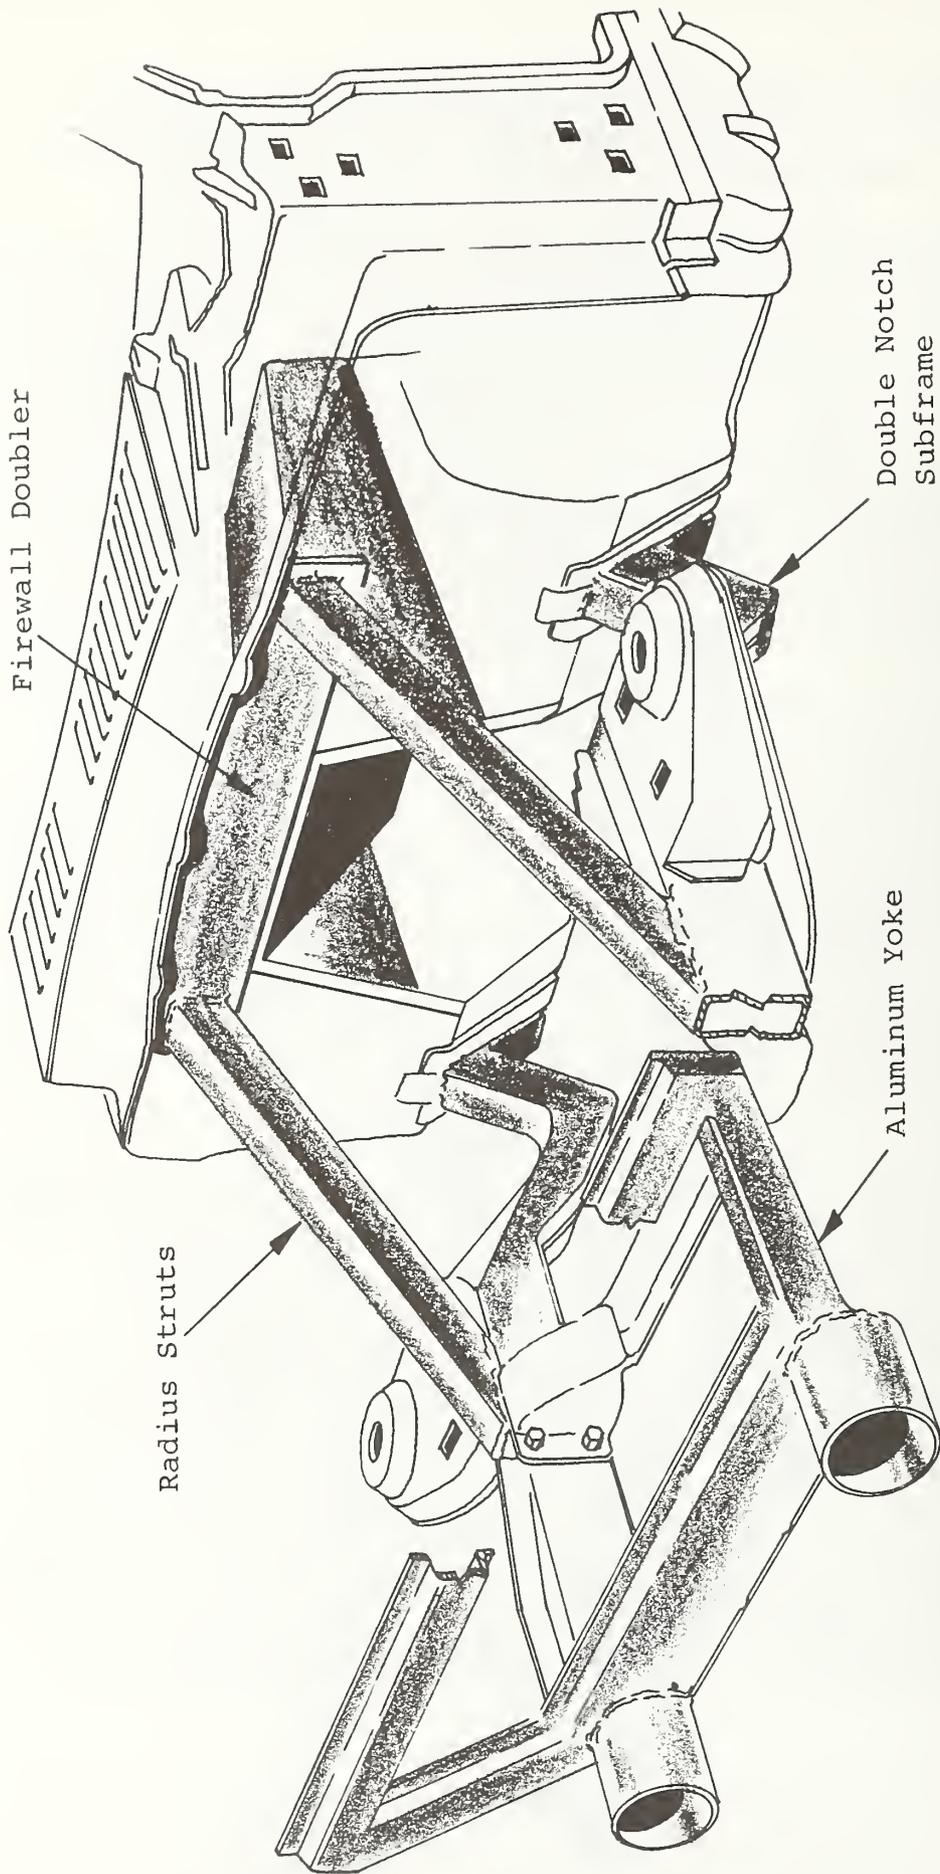
FIGURE 3.18 LOWER FRONT STRUCTURE FOR TEST ARTICLE D5

Test D5 was a 40-mph 30° barrier test. The vehicle impacted left side first, crushing the upper structure to a 30° angle. The vehicle remained parallel to its original velocity vector during the early portion of the crush, sliding parallel to the barrier. Then the left wheel stuck in the plywood barrier face and the vehicle rotated parallel to the barrier. It came to rest parallel to the barrier about 6 feet from its initial impact point. As with Test D4, there was no pitch of the vehicle. The crush on the left side was 37 inches, and in the center it was 6 inches. The left A post moved 4.5 inches aft. The lower structure did not behave completely as desired. The Z section in the aft frame collapsed as predicted, but the radius arms did not rotate downward. Thus the engine did not deflect as

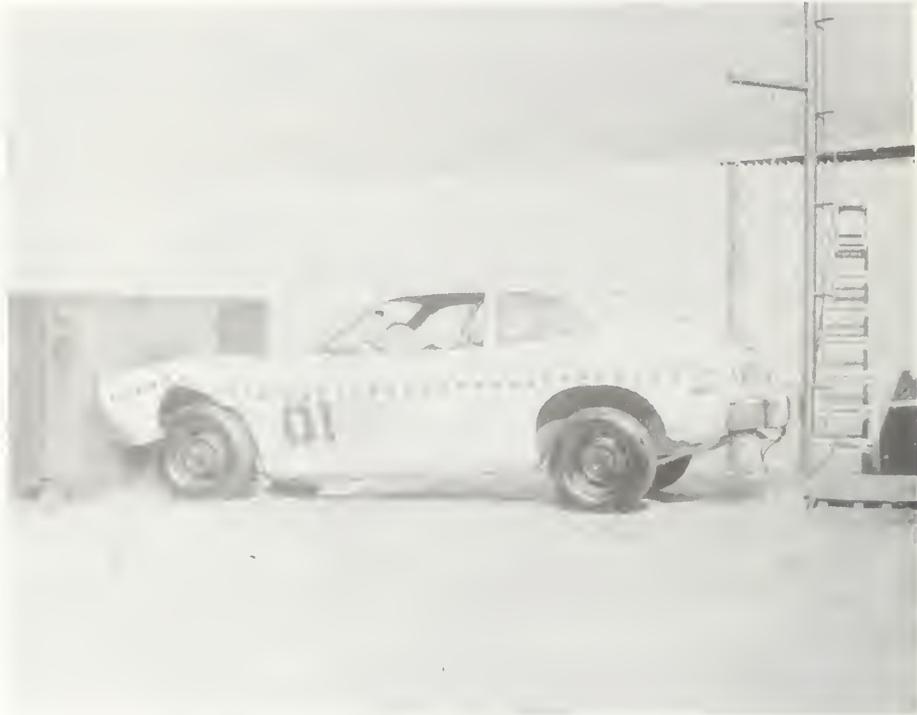
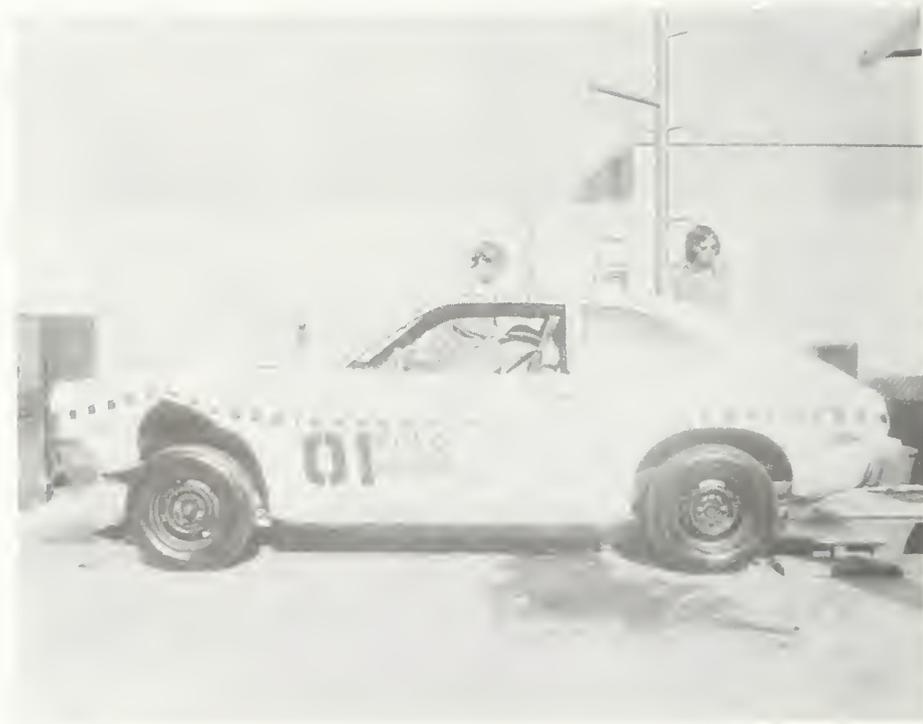
FIGURE 3.23 BASELINE TEST NO. 001

C. Impact

D. Post-Test Driver's Side

purpose of the modification was to provide data for the determination of strain rate effect. Recorded data also included photographic coverage of the event. All instrumentation functioned properly during the test. The data is summarized in Table 3.5. The entire data package was presented in the test report included as an attachment to the December 1973 progress report. (An index of the baseline test reports is given in Table 1.1.) An overview of the photographic coverage is shown in Figure 3.23.

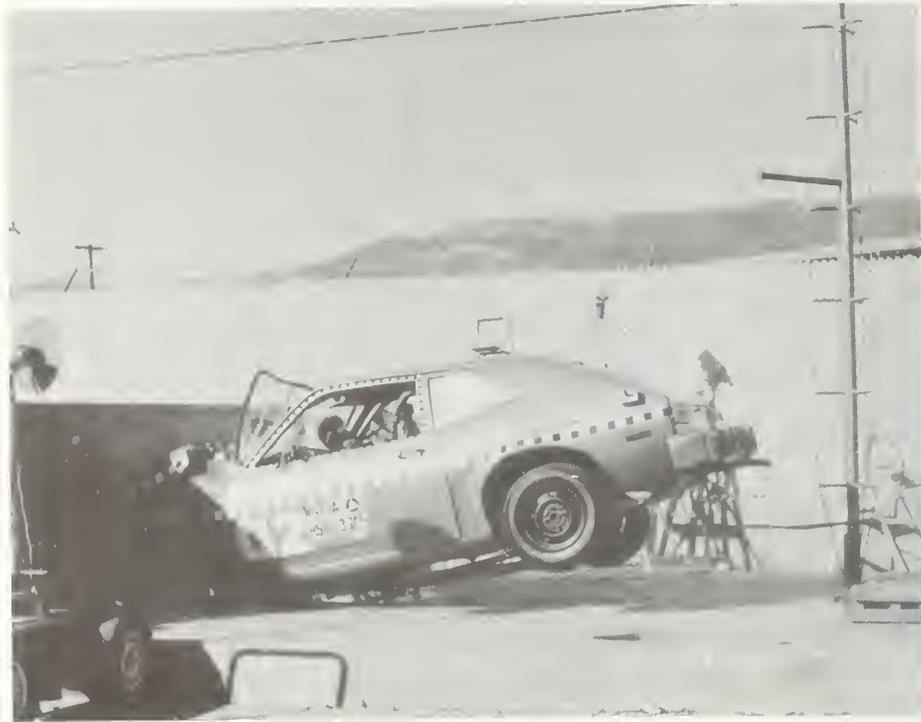
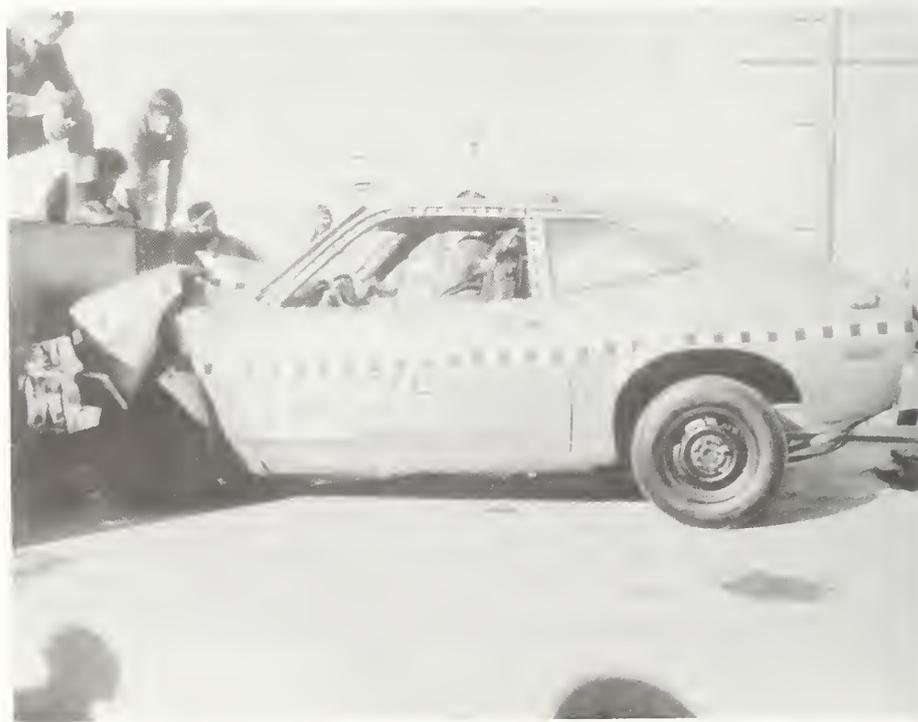
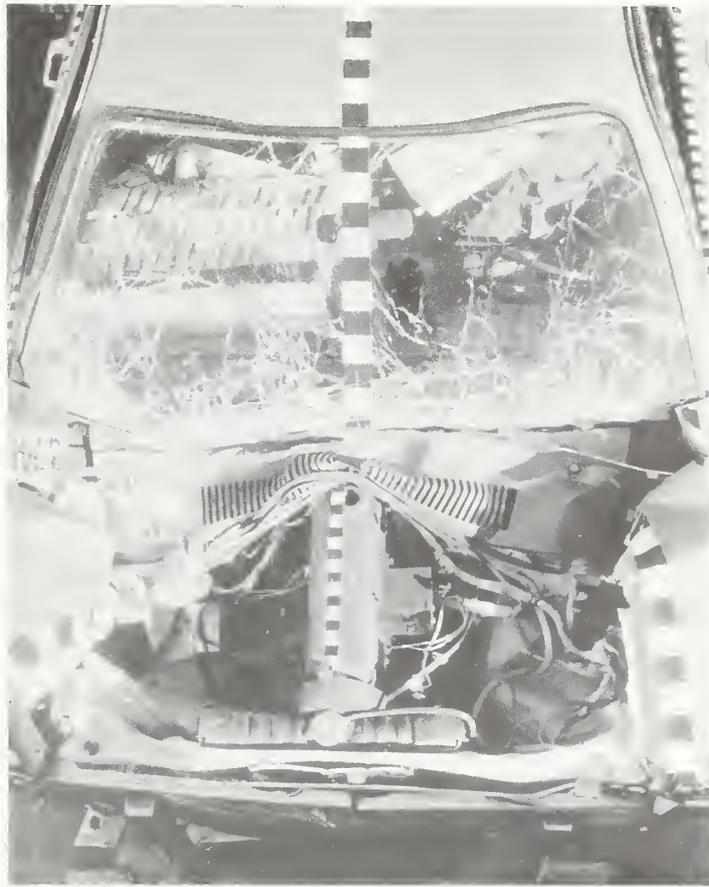
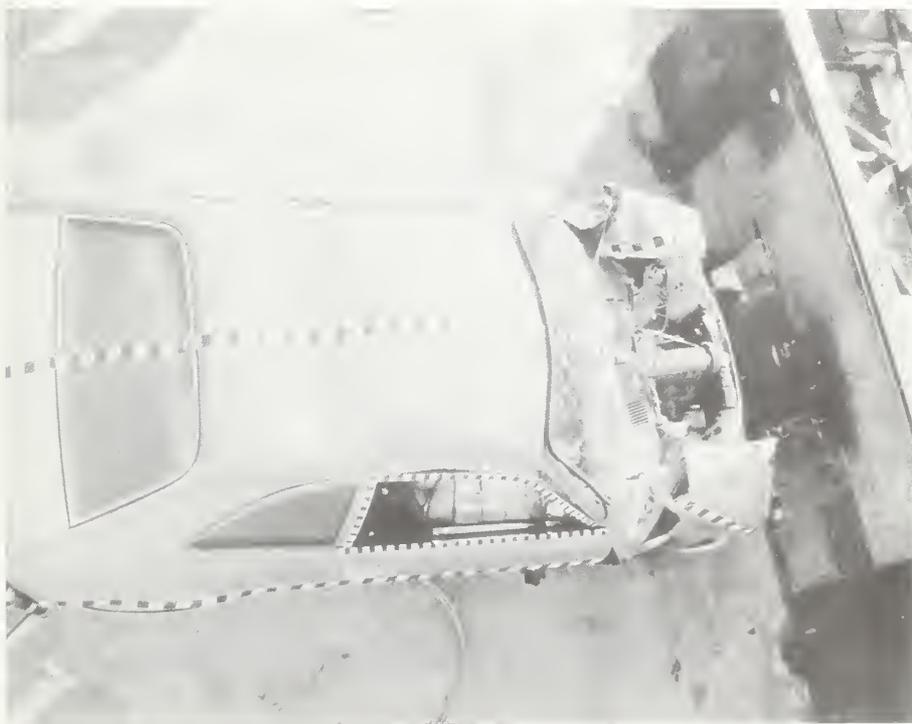
FIGURE 3.24 BASELINE TEST NO. 002

Structural Damage: Damage/deformation was severe throughout the forward two-thirds of the vehicle. The bumper energy absorbers were completely stroked, sheared from their frame mounts, and driven back to the cross member under the engine, where they deformed components of the steering system. The front subframe members were buckled both fore and aft of the engine cross member and suffered plastic bending where they joined the firewall, resulting in toeboard and firewall distortion. The front cross member, though it was moved rearward, showed little deformation and seemed to be, together with the engine block, the strongest front-end structure. As a result of the high impact energy, the "soft" structures in front of the engine were completely crushed, and the block itself struck the barrier, with the resulting high force level exerted on the entire drivetrain. The motor mounts were displaced inward and to the rear, and the engine block was pushed a significant distance into the firewall. The bell housing was cracked in several places and the transmission moved down and to the rear to such a degree that the transmission vibration damper struck the ground. The differential showed noticeable damage, with the right leaf spring and shock absorber bent and the left axle tube broken on the inboard end. Firewall deformation was marked, due to the engine and front frame bending. Front end sheetmetal deformation was severe, with the fenders being buckled and sheared from the wheel wells and associated inner panels. In addition to the frame bending at the firewall, a line of lateral bending developed immediately behind the front seats, resulting in door frame distortion, roof buckling, and passenger compartment deformation.

A. Impact

B. Post-Test Driver's Side

C. Post-Test Engine Overhead

D. Post-Test Overall Overhead

Baseline Test 02 was a 40-mph frontal barrier test of a 1974 Pinto two-door sedan. The test was essentially identical to Test 01 (Section 3.3.1.1) except for the higher impact velocity. The data summary is given in Table 3.5, with the complete data package reported in the test report (December 1973 progress report). An overview of the photographic data is shown in Figure 3.24.

Passenger Compartment Intrusion: Some compartment intrusion resulted from the impact. Although there was little deformation of either the A or B posts, firewall stroke and chassis bending near the B post caused both doors to jam tight. The toeboards were displaced rearward due to engine stroke and lower firewall buckling with associated front footwell buckling. Although the steering column was stroked only slightly, dummy "driver" impact deformed it up and to the left of the vehicle. The harness/belt system seemed to have limited effect on the dummy "driver," since the dummy struck the steering column with some force and was also allowed to contact the windshield header. The crash bolster on the dummy "passenger's" side seemed to have been of some benefit. Seat damage was most severe on the passenger side, possibly as a result of dummy rebound from the stiff crash bolster. Buckling was also in evidence in the rear footwells, due to chassis bending at that point.

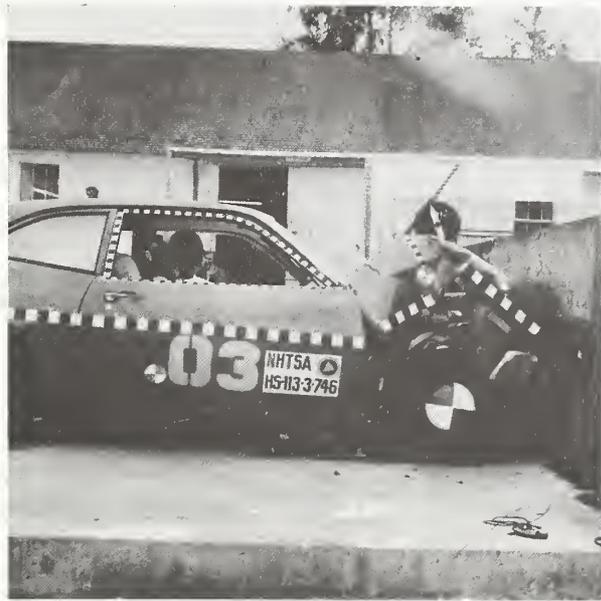
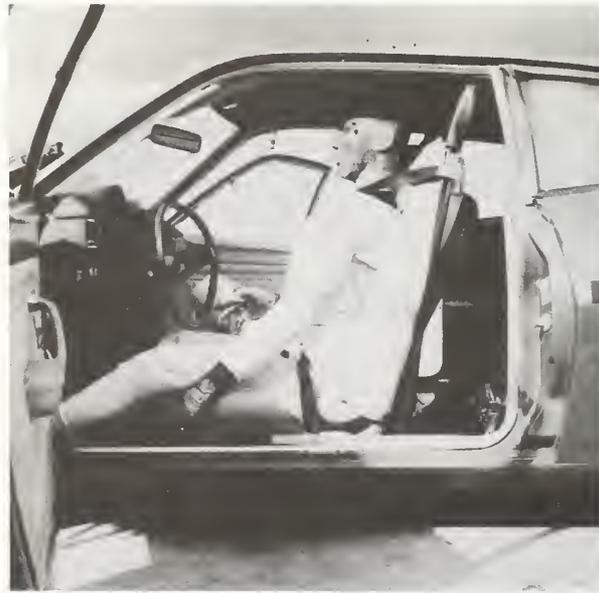
FIGURE 3.25 BASELINE TEST NO. 003

Structural Damage: Damage/deformation was concentrated in the front half of the vehicle. The bumper energy absorbers were completely stroked, sheared from their frame mounts, and driven rearward to the steering system. The front subframe members were severely deformed forward of the engine

A. Post-Test Passenger's Side

D. Post Test Dummy Position

cross member. The cross member showed little distortion but was displaced toward the rear. All "soft" structures ahead of the engine were completely crushed, and the engine itself was moved rearward into the firewall. Engine displacement was approximately 6 inches, producing significant deformation of the firewall itself, but, due to rotation of the engine, caused minimal driveline damage. Front end sheetmetal deformation was severe, with the fenders being buckled and sheared from the wheel wells and associated inner panels. The fender displacement also caused jamming of both doors; in the case of the right-hand door, forces were large enough to shear off the outer door skin.

Baseline Test 03 was a 30-mph frontal barrier test of a 1974 Pinto two-door sedan. This was similar to Tests 01 and 02. The instrumentation of the subframes was deleted from the final instrumentation in accordance with the baseline test plan. The data summary is presented in Table 3.5, with the complete data package presented as an attachment to the April 1974 progress report. Photographic coverage of the test is shown in Figure 3.25.
